Flexible Braided Stainless Steel Hose Failures

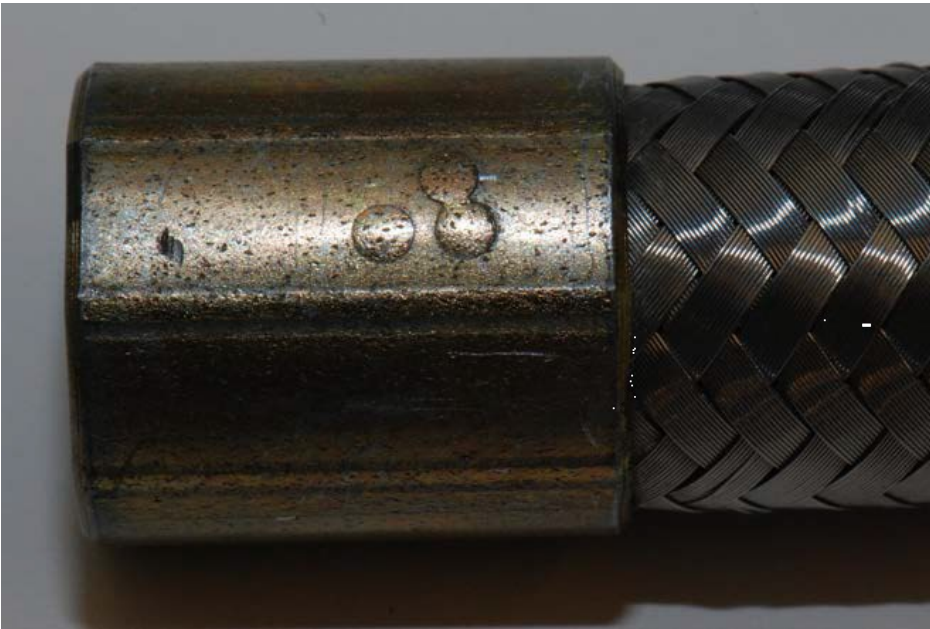
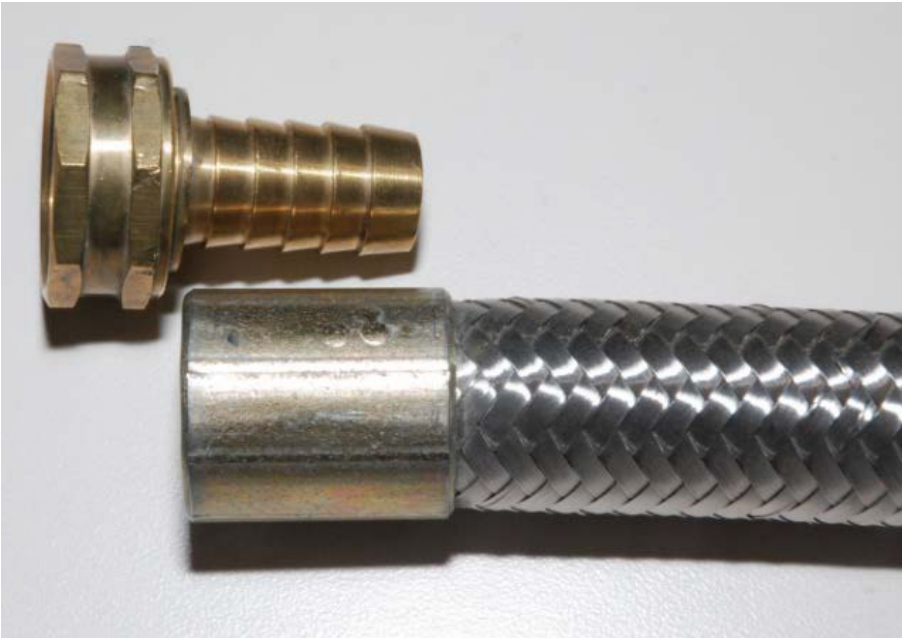
Cozen O'Connor is handling several matters in litigation in Canada involving the failure of braided stainless steel hoses on water source heat pumps. The hoses allegedly have been improperly manufactured. The failure mode at issue in the litigation is that the garden hose-style fitting slips out of the hose, an example is pictured below. The fittings are secured in place with steel sleeves – known as ferrules – that are crimped around the hose fittings to hold them in place. Through our research and investigation with engineers specializing in material failures, a batch of 500 braided stainless steel water hoses manufactured in or around July/August of 2011 may have been improperly crimped or otherwise improperly manufactured and tested, causing the fittings to slip out of the ferrule.

- Three circular bumps arranged in a triangle fashion on the metal sleeve intended to hold the coupling in place (example below); and
- A label indicating that the hose was pressure-tested in or around July-August of 2011.

The Canadian litigation is proceeding on a court-ordered timetable stipulating that examinations for discoveries and mandatory mediation are to be completed by December 31, 2016. If you are aware of a failed hose exhibiting these features notify Cozen O'Connor before July 15, 2016. We may be able to include a claim for your losses caused by the hose failure in the present litigation.
